Measurement of surface subsidence and ground collapse caused by underground mining in the Boleo Copper District, Mexico

Jong-Gwan Kim

Department of Energy and Resources Engineering, Chonnam National University, Republic of Korea

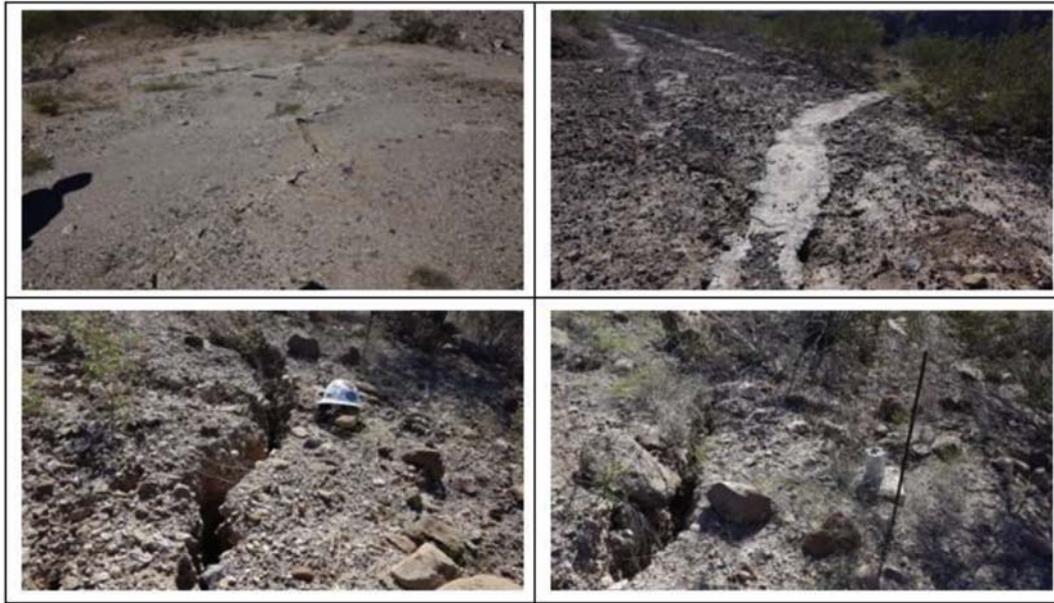
To circumvent the Manto3 area, step mining was applied to reach the ore body after excavating through the upper interburden of Manto3. In the case of conglomerate and repeated grading to support the lateral pressure, severe abrasion and pillar damage was caused. Measurements of crack displacement and cement injection were conducted. In addition, penetration through the cracks during the rainy season was not observed, as depicted in Fig. 2.

Fig. 2. Observed cracks at M303.

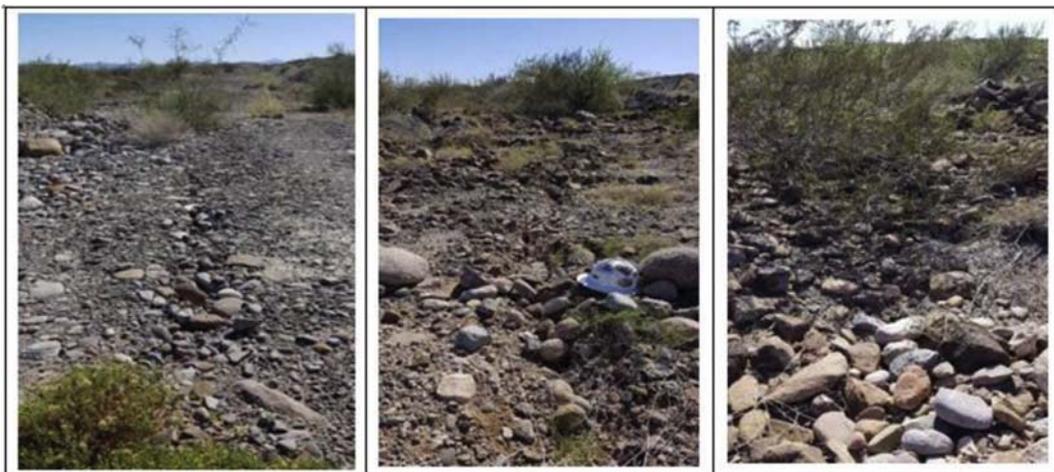
After M303 mine was abandoned, three portals were developed in Soledad valley, south side. Excavation was stopped because of the inadequate effect of rock-bolt support, lack of ability to deal with the Retaque section, excessive layer separation of Manto 3A, and excessive use of wood-log support. As a result, retreat mining was executed. In the case of retreat mining, the surface cracks near the upper road of Mesa Soledad occurred; however, most of the horizontal displacement was not accompanied by severe damage, such as road

destruction. Mine M303S exhibited upper cracks, as illustrated in Fig. 3.

Fig. 3. Observed cracks at M303S.

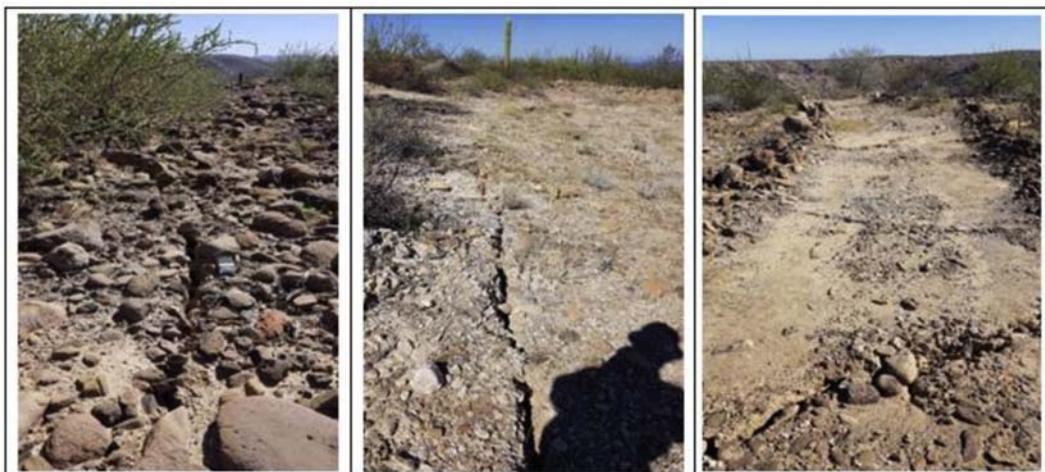
M303S mine site is retreat mining termination opens new portal with two entries. First application of steel arch system, various tests (shotcrete, trimesh, semi-shield, short wall mining, conglomerate excavation, etc.). A large number of cracks, 5–10 cm in size, were observed in the upper part of the pit area using short wall mining. Because these cracks are far from the road, they do not affect the

Fig. 4. Observed cracks at M303C.

equipment or vehicles. Fig. 4 illustrates the view of cracks on site.

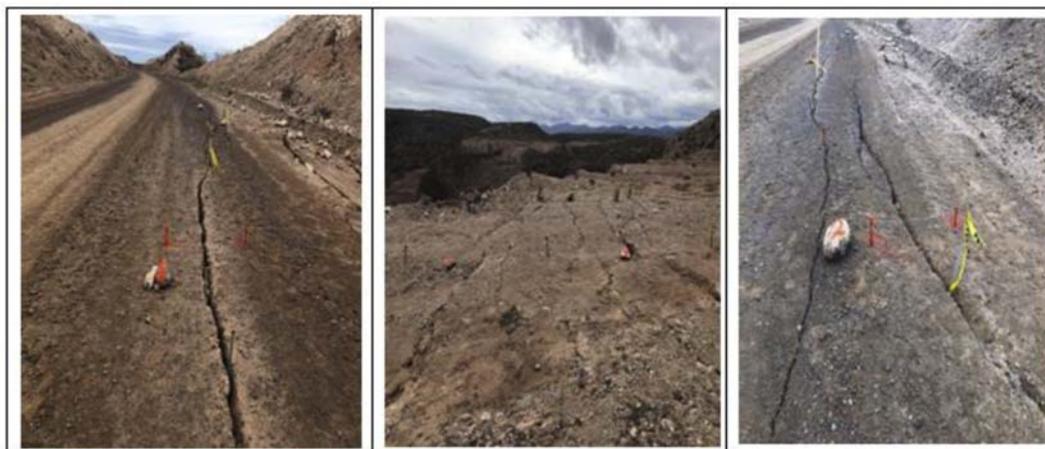
For the purpose of short wall mining, the main gateway is excavated in the Manto3 layer and this mine has two panels. The section of panel SW1 is 80 m and 2.4 m high, and currently has advanced to approximately 90 m, which results in a volume of approximately 17,280 m³ of extracted ore at present. This working face was started on August 6, 2018. As the production of this panel continued, some cracks were observed in the upper transportation road and valley slope. We started monitoring on October 31, 2018 in the area known as “Mesa soledad.” The panel is located at an average depth of 60.68 m from the surface (Fig. 5).

Fig. 5. Observed cracks at M305.

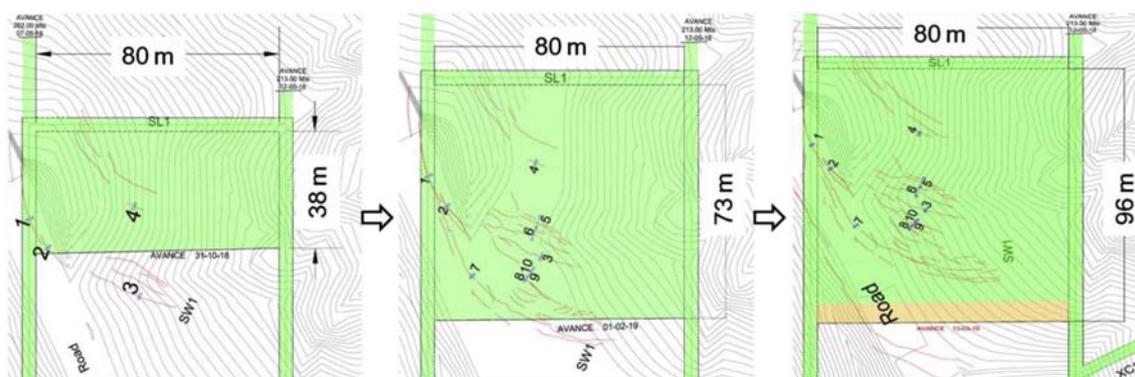
Fig. 7. Crack variation by development progress.

caused by a car. Its new measurement was 1.332 m. Comparing the three stages, we infer that the number and length of the cracks increased significantly, as the mine production continued (Fig. 7).

the center of the excavated area in SW1, which indicates towards the subsidence of the rock mass due to the excavation on M305 SW1. The three stages of the topographic survey are depicted in Fig. 7. The results of ground monitoring are presented in Table 1.

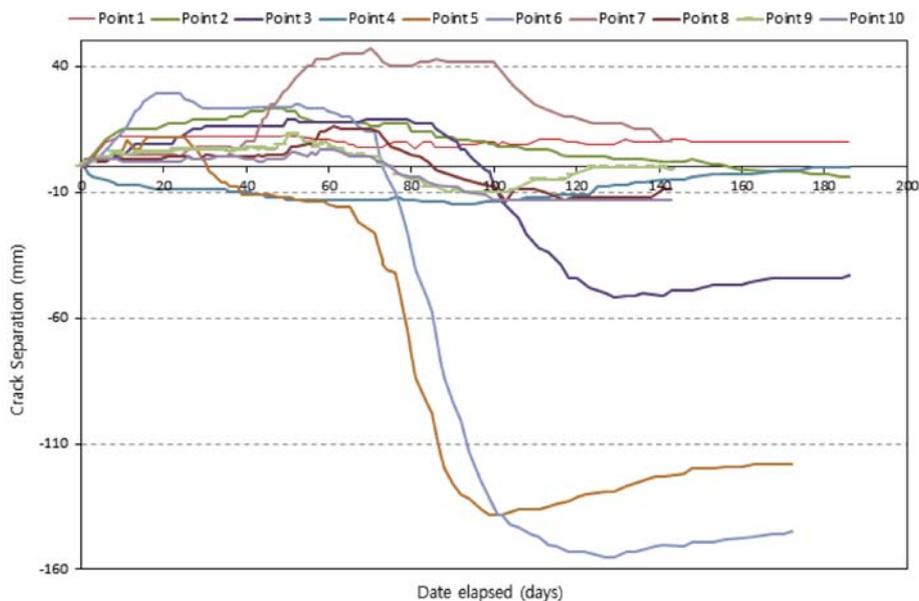
Fig. 8. Ground monitoring graph.

Fig. 8 depicts the total displacement with respect to the number of days passed since the installation of each point. When the third topographic survey was carried out and the points were updated on the map, it was observed that the points moved towards the central area of the mined area in M305 SW1.

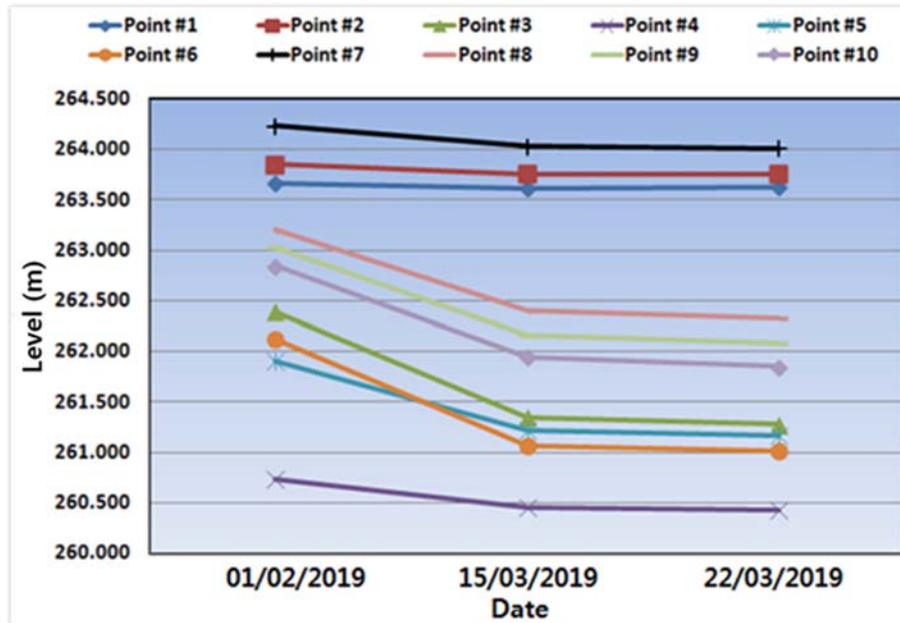
Fig. 9 depicts the subsidence status of each point; the total subsidence has a value between 40.5–1,114 mm and the maximum subsidence rate is 22.7 mm/day.

Fig. 9. Level of points plotted with respect to the number of days.

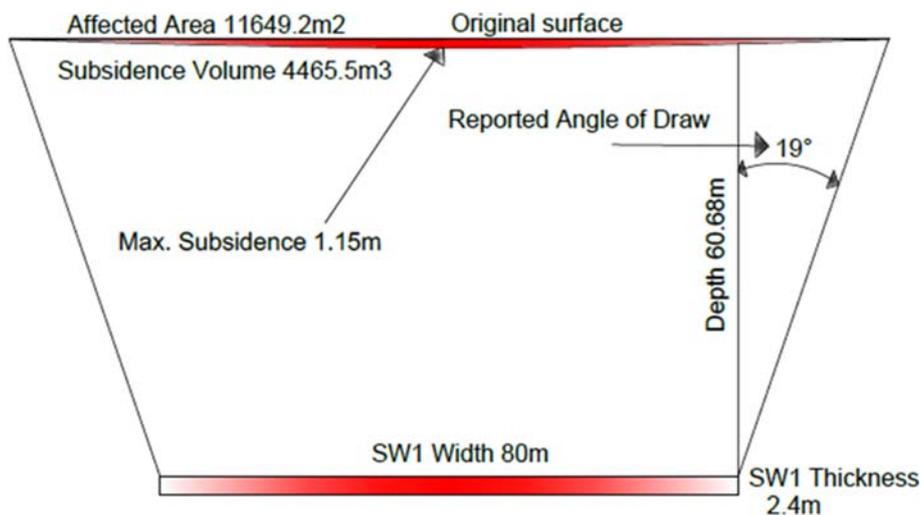
Fig. 10. True scale subsidence of M305 SW1 using a reference angle of draw.

with a diameter of 121.78 m, as SW1 is 60.68 m deep and 80 m wide, resulting in an area of 11,649.2 m² (see Fig. 10). Using the data obtained from the subsidence monitoring, cone geometry was assumed to calculate the subsidence volume as 4,465.5 m³. As the ore density is 1.41 tones/m³, the approximate subsided weight is 6,296.35 tones. By taking as reference the most remote cracks on the monitored area, it was assumed that the affected area is a 110 m diameter circle, resulting in an area of 9,503.03 m². As the SW1 depth is 60.68 m, the obtained angle of draw of the subsidence is 14° and

the subsided volume is 3,642.9 m³. As the ore density is 1.41 t/m³, the approximate subsided weight is 5,136.5 tons.
