# Investigating the effectiveness of a ground support system implemented on Block A: A case study of Southern Africa Metalliferous Mine

Kamogelo Manyelo <sup>a,\*</sup>, Peter Kolapo <sup>b</sup>

This study aims to investigate the effectiveness of the ground support systems that are planned to be implemented on Block A, which will be excavated through the Marikana fault zone. The block of ground being prepared for mining has been physically affected by the presence of the Marikana fault and is therefore geomechanically and geotechnically weaker than the normal stoping conditions on the rest of the shaft. Data collected during the raiselines mapping was used as input into the numerical modelling software (Dips and JBlock), which indicated a major scatter of joint orientations in Block A. Shallow dipping orientations of  $276^{\circ}/14^{\circ}$ ,  $174^{\circ}/11^{\circ}$  and  $69^{\circ}/14^{\circ}$  were observed. An average RMR below 50 was calculated from the field mapping data which indicates that the quality of the rockmass in Block A is relatively poor and pose the risk of rock falls due to high probability of unstable rocks. Jblock simulations were performed to estimate t

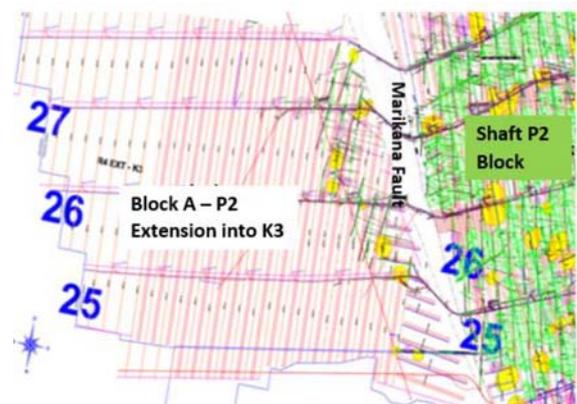
Fig. 1. Image showing the Marikana fault zone.

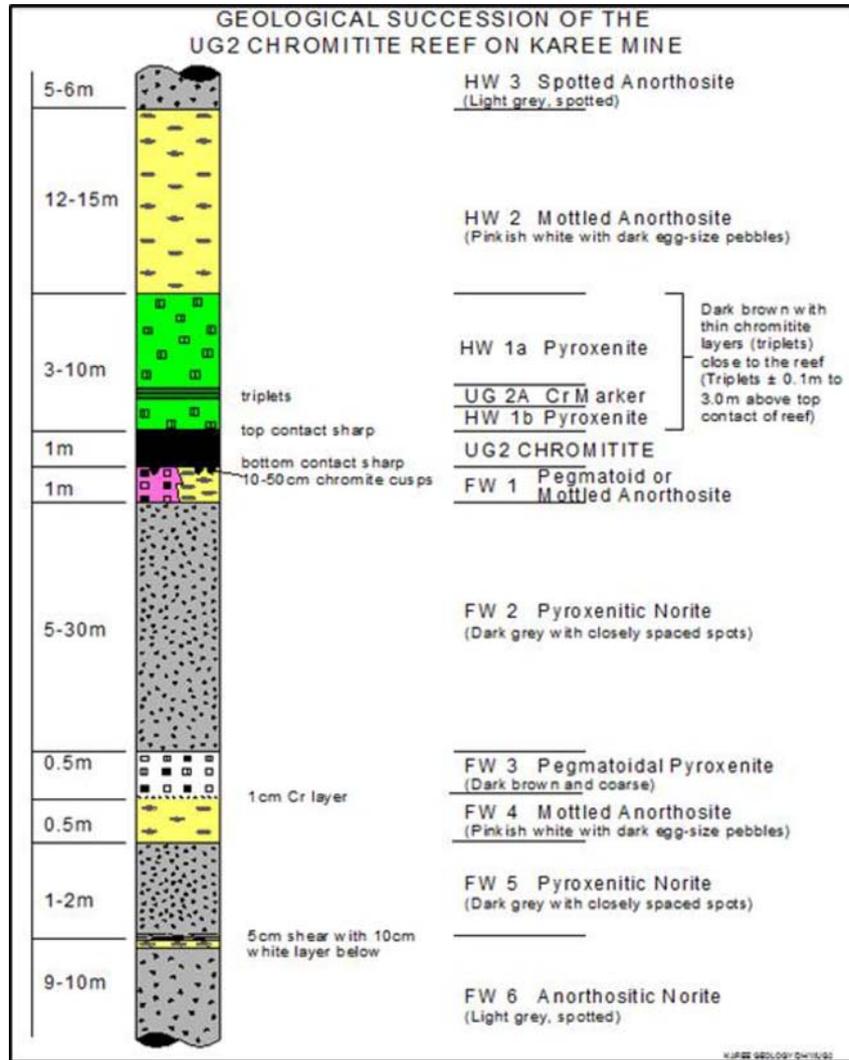
Fig. 2. Typical stratigraphic column showing the lithology of the UG2 Reef in Block A.

At Mine X, the UG2 underlies the Merensky Reef by approximately 130–210 m, increasing from west to east across the Marikana operations [5]. As a result of the variable stratigraphic distance between these ore bearing horizons, each of these reef horizons is influenced by different geological features [6]. The geological sequence in Fig. 2 shows alternating layers

of pyroxenite, norite, mottled anorthosite and chromitite. Across the mine, the general mining layout is an up-dip configuration with dip stabilizing pillars, stoping through two panels on either side of a center raise at a panel length of 15 m. Block A is planned to exploit the UG2 Chromitite Reef in this type of stoping configuration.

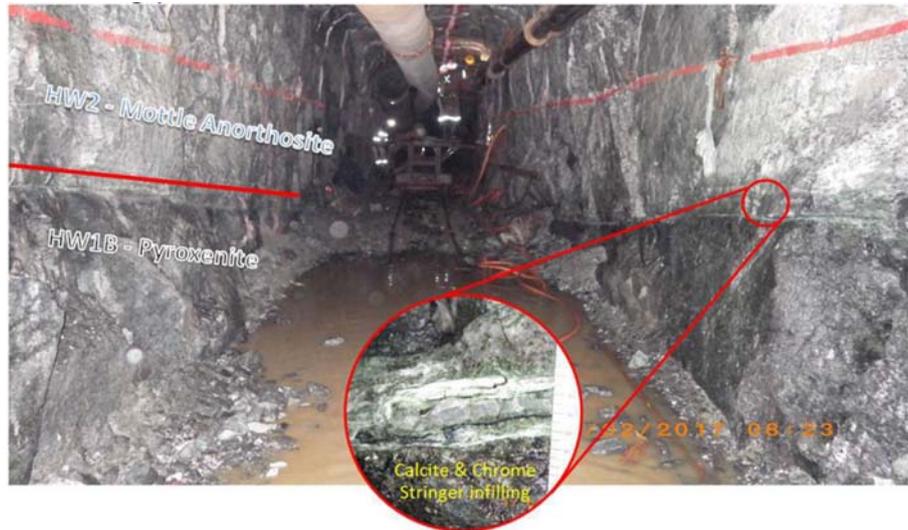
Fig. 3. 27C west 103 raiseline.

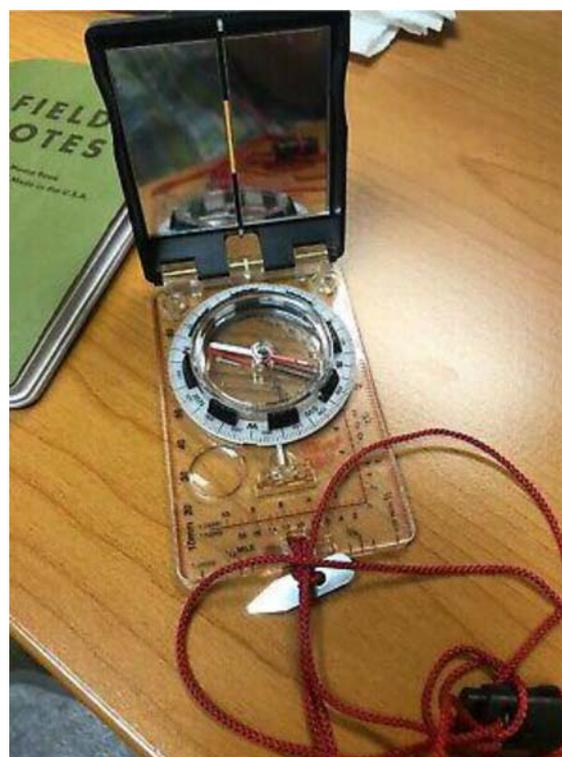
Fig. 4. Image of Silva foldable geological compass.

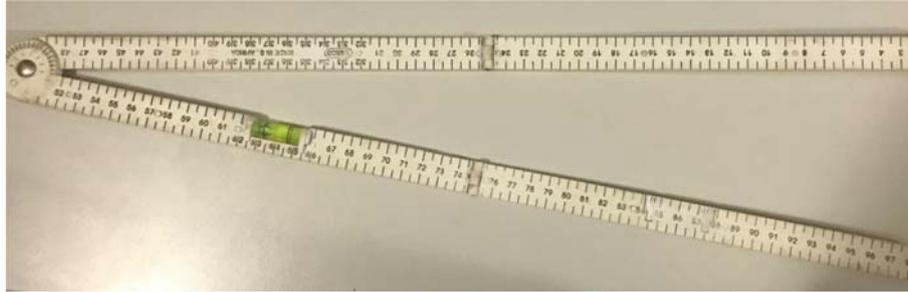
Fig. 5. Image of 1 m clino-rule.

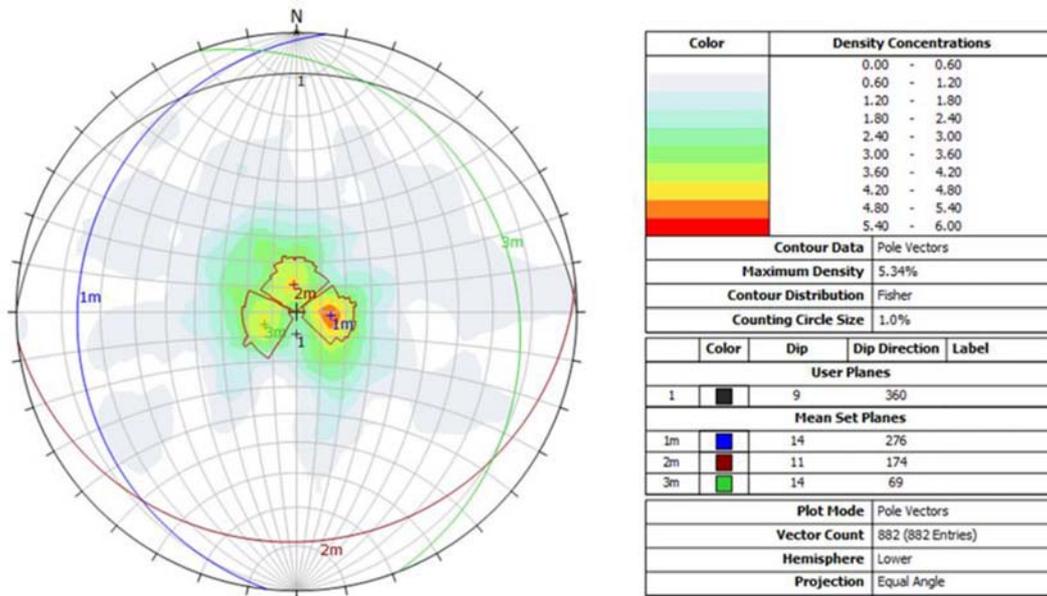
Fig. 6. Stereonet projections of major joint sets identified.

From the joint mapping result, underground joint mapping were plot as input data into DIPS software to provide the structural data as shown in Fig. 6.

Plotting the dip and dip directions allowed for the visual depiction of the variability of joint orientations. Contouring the pole plots also allowed for the dominant joint sets to be identified. The stereonet results from DIPS indicated that there are three prominent joint sets dipping in opposite directions and intersecting triplets. Where these joint sets (set 1m and set 3m) intersect the triplets, a wedge is

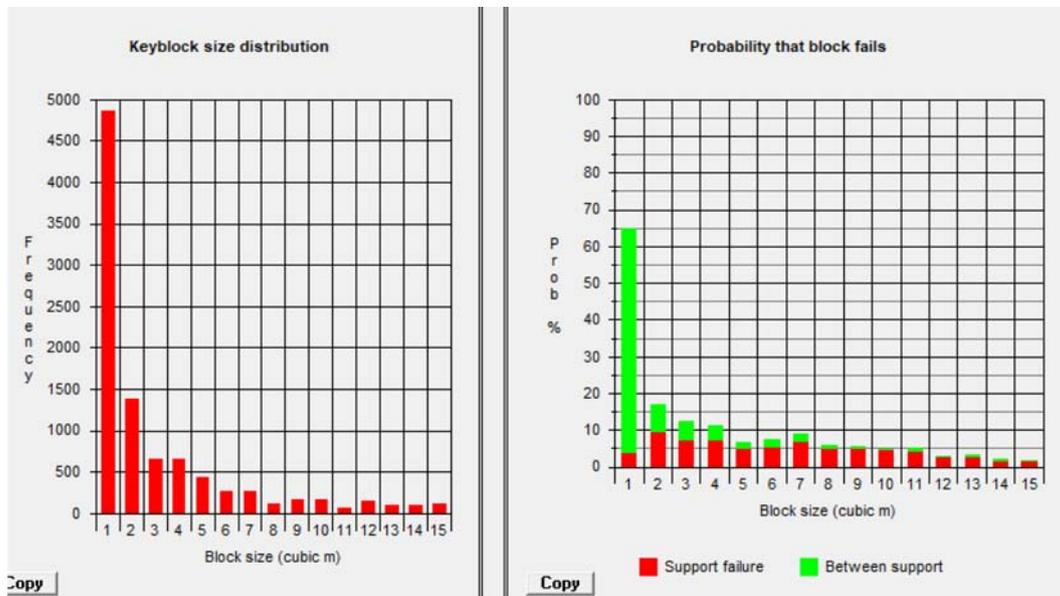
Fig. 7. Probability of block failure based on the current support system.

The results of JBlock simulations are indicated in Figs. 7 and 8. These results represent the frequencies of different sized keyblock distributions and probabilities that these keyblocks would fail. Geotechnical data was collected using scanline mapping methods. The joint data was analysed using Rocscience's Dips. Jblock was then used to compare the different support scenarios. Potential keyblocks are generated based on the geotechnical file and an excavation file in JBlock. The geotechnical file describes the ground conditions to assess. Due to insufficient fall out thickness data to dictate the parameters of the design, the highest value was used from the surrounding Ground Control Districts (GCD's) to account for the worst expected scenario based on recorded data. The thickness used was therefore 1.2 m as found in the surrounding GCD's.

The unstable keyblocks were simulated by first using the current support system of 1.6 m long ungrouted roof bolts spaced 1.2 by 1.2 m, with a 100 kN load bearing capacity and 750 mm

diameter grout packs with a load bearing capacity of 2200 kN. The area simulated is a stopping panel with a 15 m face length and a 30 m back length. A total number of 10 000 keyblocks were generated and the probability of failure was highest for 1 m<sup>3</sup> at a 60% probability of failure in between support. This suggests that the probability of block failure obtained is high, thus indicating that the support is insufficient. The support spacing was too wide and resulted in a greater percentage of 1 m<sup>3</sup> keyblocks falling in between support. The findings indicated that the planned support system for Block A is not sufficient and requires a higher support resistance.

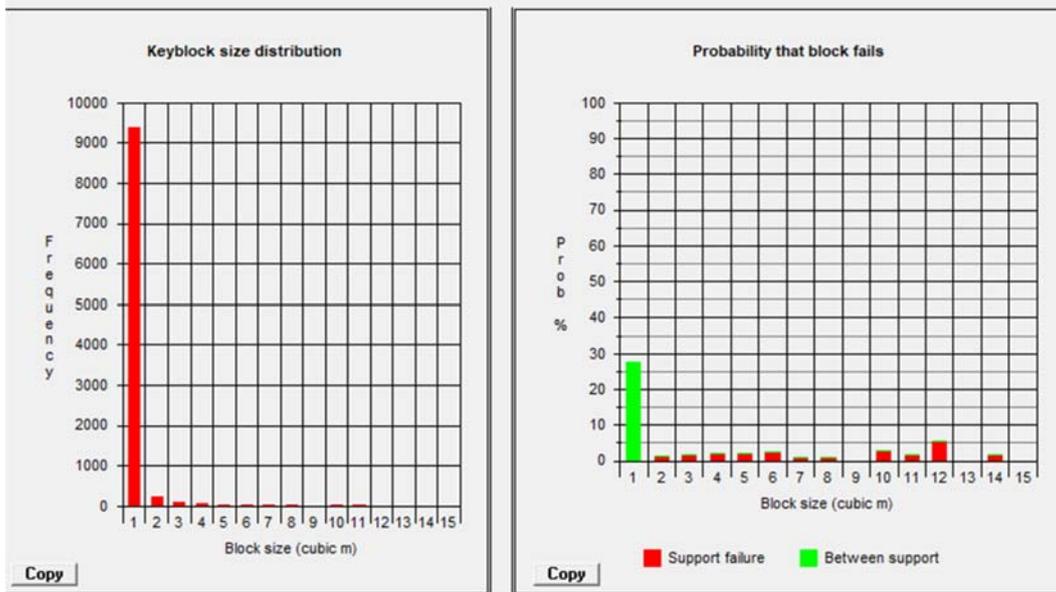
Fig. 8. Probability of block failure based on the new support system.

The recommended support system consists of grouted tendons with a load bearing capacity of 160 kN, 2.2 m length, and spaced at 0.5 × 1.2 m. The new support system yields the results shown in Fig. 7. The probability of block failure for 1 m<sup>3</sup> blocks decreases to 27%, and the maximum support failure to 5%. The JBlock analysis shows that the support spacing implemented at Mine X does not sufficiently account for all rockfalls that can occur due to keyblock formation in the hangingwall.

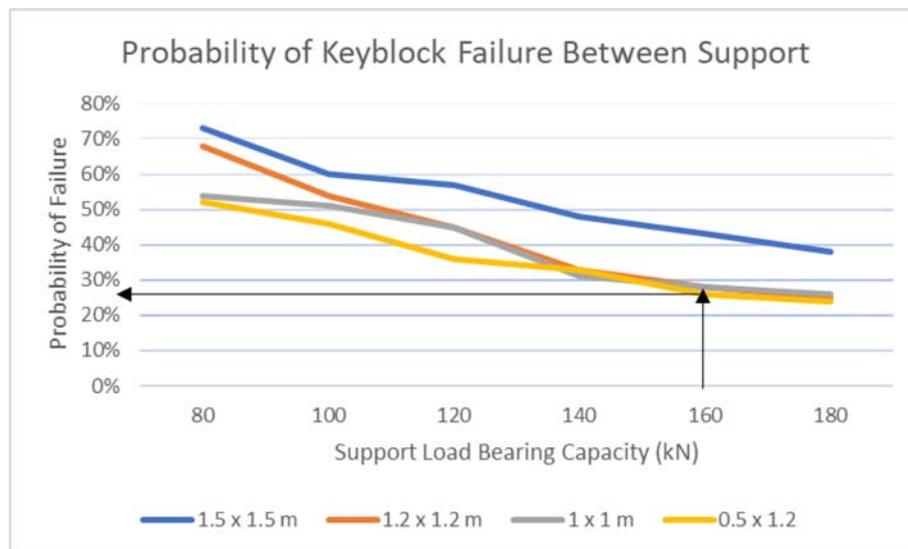
Fig. 9. Probability of Keyblock failure in between support elements.

In order to determine the optimum load bearing capacity for the roof bolts, simulations were done at different support spacings and different support bearing capacities. The results are indicated in Figs. 9 and 10. It is evident that at a load bearing capacity of 160 kN, there is a reduced probability of failure at 26% in between support as opposed to a 60% probability using 100 kN capacity. Furthermore,

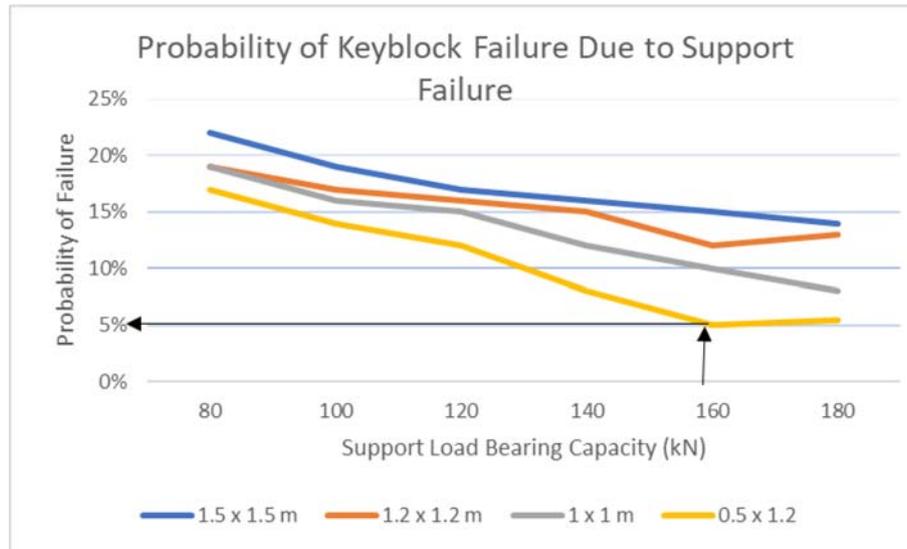
Fig. 10. Probability of Keyblock failure in between support elements.
