Measurement of surface subsidence and ground collapse caused by underground mining in the Boleo Copper District, Mexico

Jong-Gwan Kim

Department of Energy and Resources Engineering, Chonnam National University, Republic of Korea

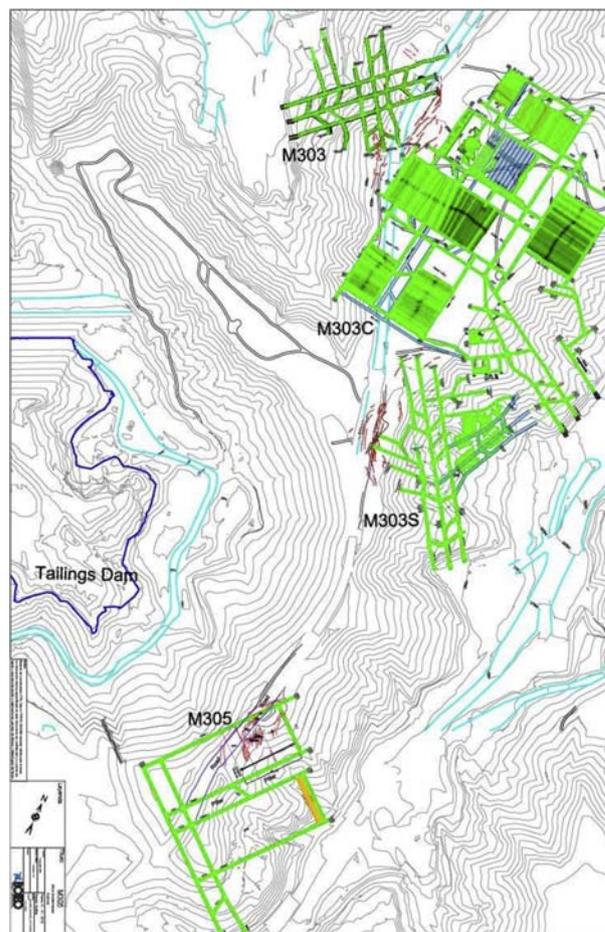
Fig. 1. Location of mines, M303, M303S, M303C, and M305.

This work is focused on the crack analysis of the mines located in the area known as “Mesa Soledad” of Minera Boleo. This analysis aims to determine the cause of cracks on the previous mines (M303, M303S and M303 C) and M305 that is current developing. Fig. 1 shows the location of each mine.

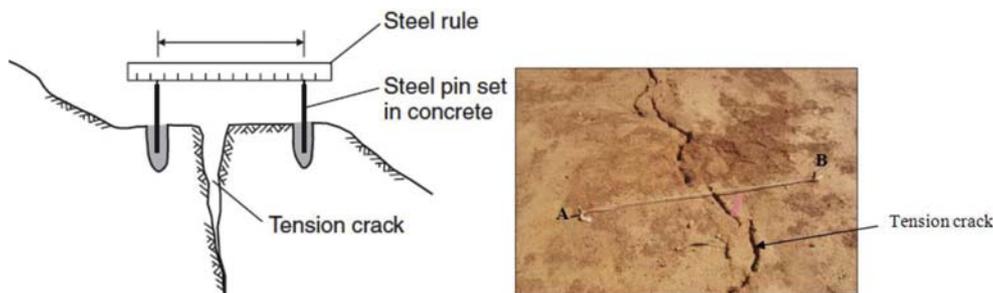
Fig. 6. Pin crack meter measuring crack displacement.

Measurement of width of the crack developed due tensile failure of the ground is a reliable and inexpensive means of monitoring ground movement. Fig. 6 shows the method of measuring crack widths. The simplest procedure is to install a pair of pins on either side of the crack and measure the distance between them with a steel tape.
